PASSAIC RIVER BASIN

# GREEN SWAMP NO. 2

## PHASE I INSPECTION REPORT NATIONAL DAM SAFETY PROGRAM

NJ 00210

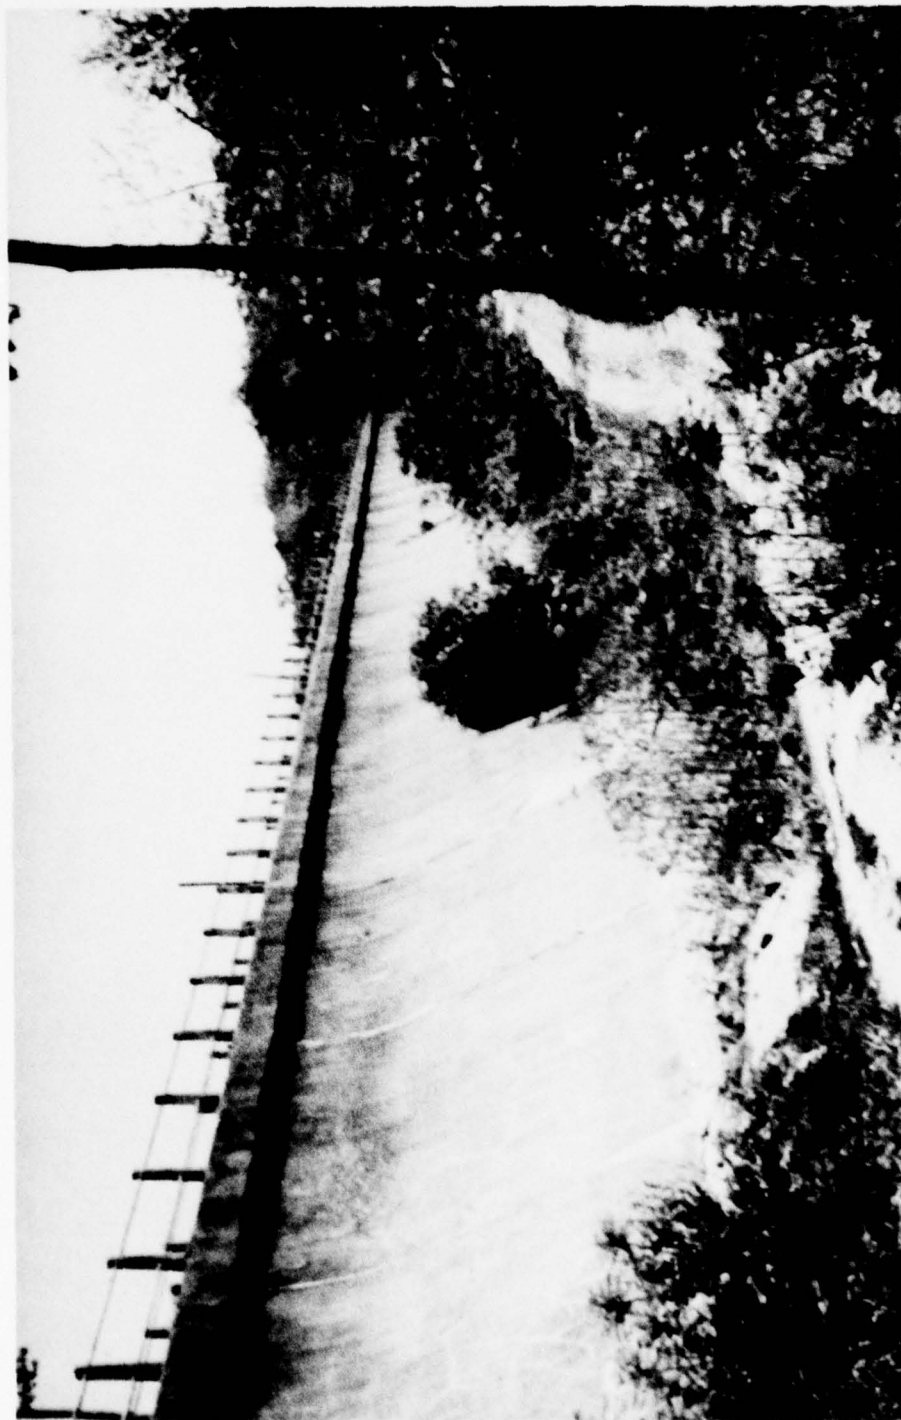
OVERVIEW PHOTO - GREEN SWAMP 2  
(DOWNSTREAM VIEW OF DAM LOOKING EAST)

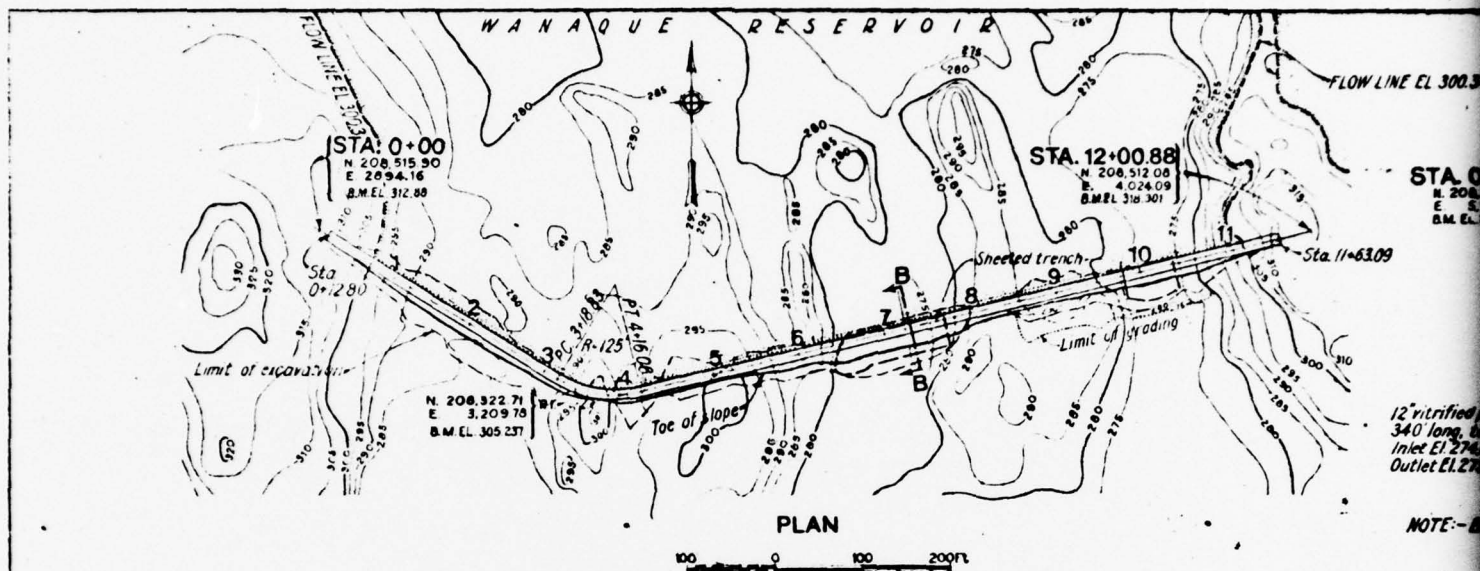
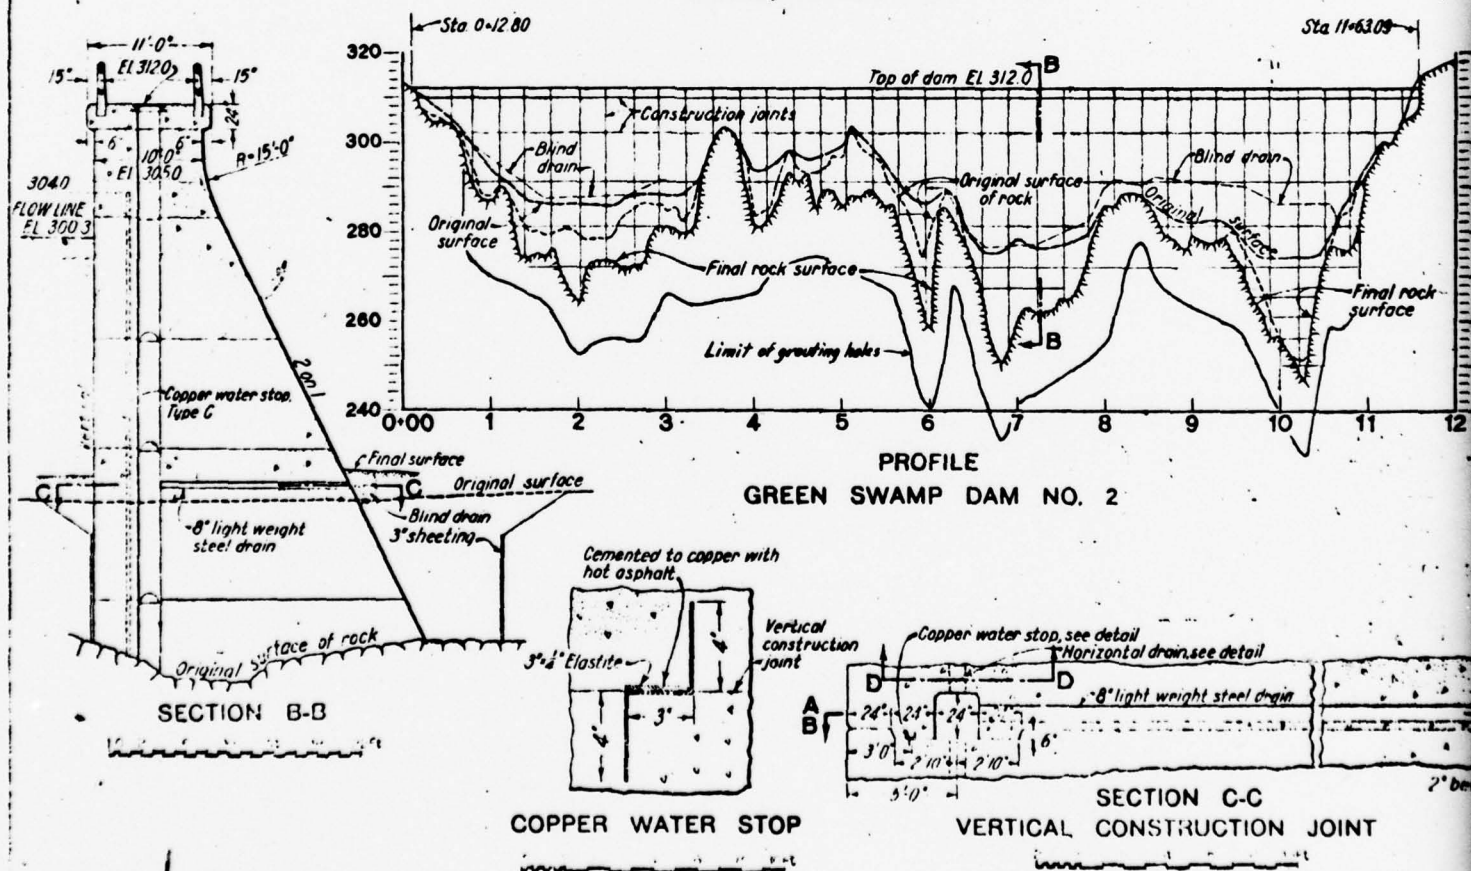
RECORD DRAWING  
SHEET 45 SHEETS IN SET 61

Record drawings, sheet 45 in a set of 61 (see Figure 2), indicate that the deepest point of the foundation excavation extends down to 28 feet below original ground giving the dam a maximum height of 66 feet.

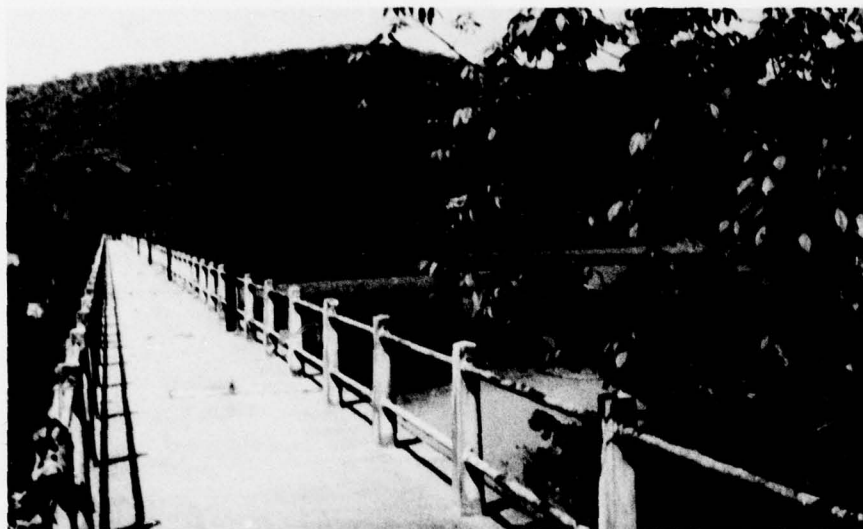
TOP OF DAM LOOKING TOWARDS RIGHT ABUTMENT

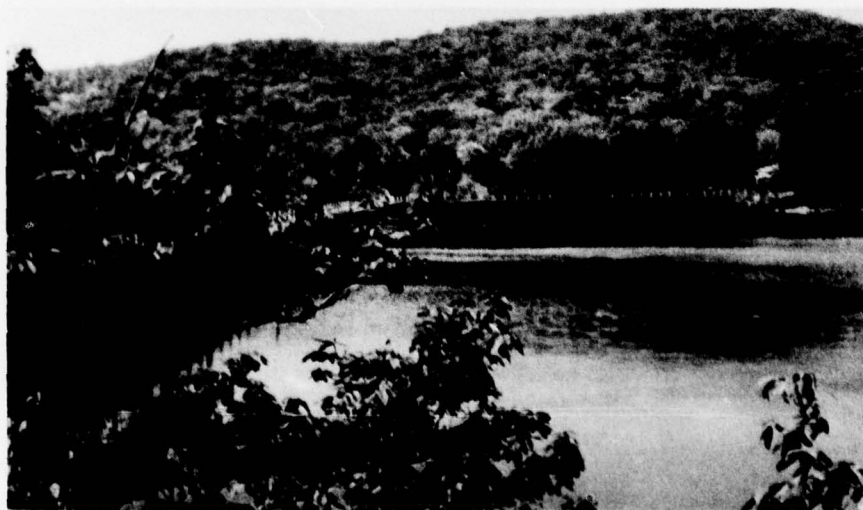
UPSTREAM VIEW

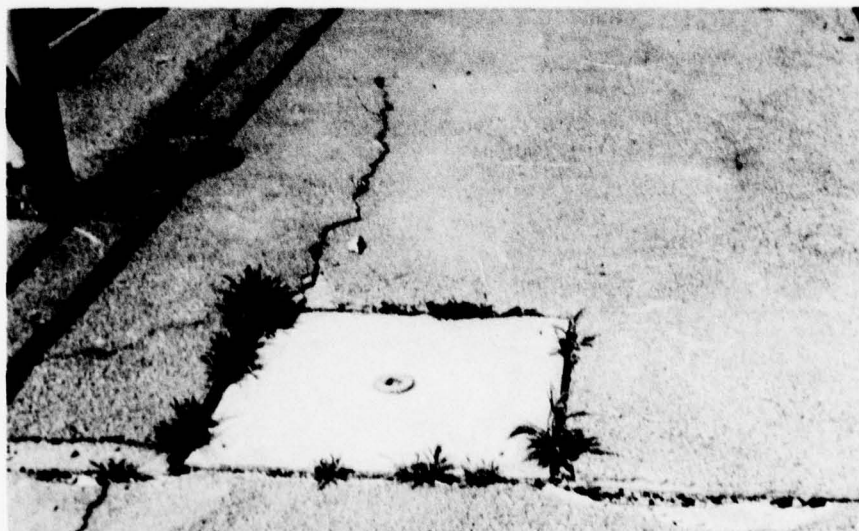
At every vertical expansion joint the gunite had cracked with some spalling and cracking of the underlying concrete. In two locations longitudinal cracking up to 1-3/4 inches deep was observed on the top of the dam in the middle of the block. The gunite on the downstream slope is starting to separate from the underlying concrete, and this has resulted in numerous random cracks, some of which are wet and exhibit exudation. The gunite has cracked and buckled at the expansion joints, and broken off in several places.

CRACKED SURFACE ALONG TOP OF DAM STA 4+55  
(FROM BEGINNING OF CONCRETE DAM AT RIGHT ABUTMENT)

(3) The covers of the vertical drains should be freed and removed to allow inspection of both vertical and horizontal drains and to determine the extent of longitudinal cracking in the dam crest, where applicable.
